# ENGINEERING ASSESSMENT

Glass Lake Dam

NYSDEC ID# 226-1344

FINAL REPORT

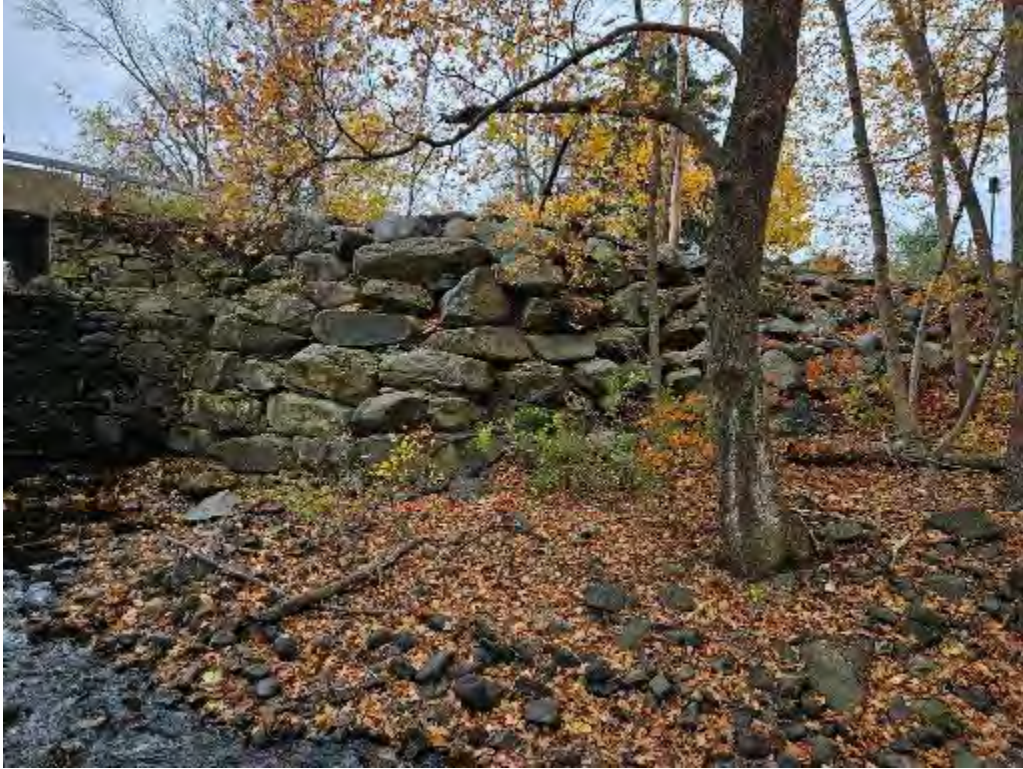
Photo 1: Rock wall on downstream side of right embankment.

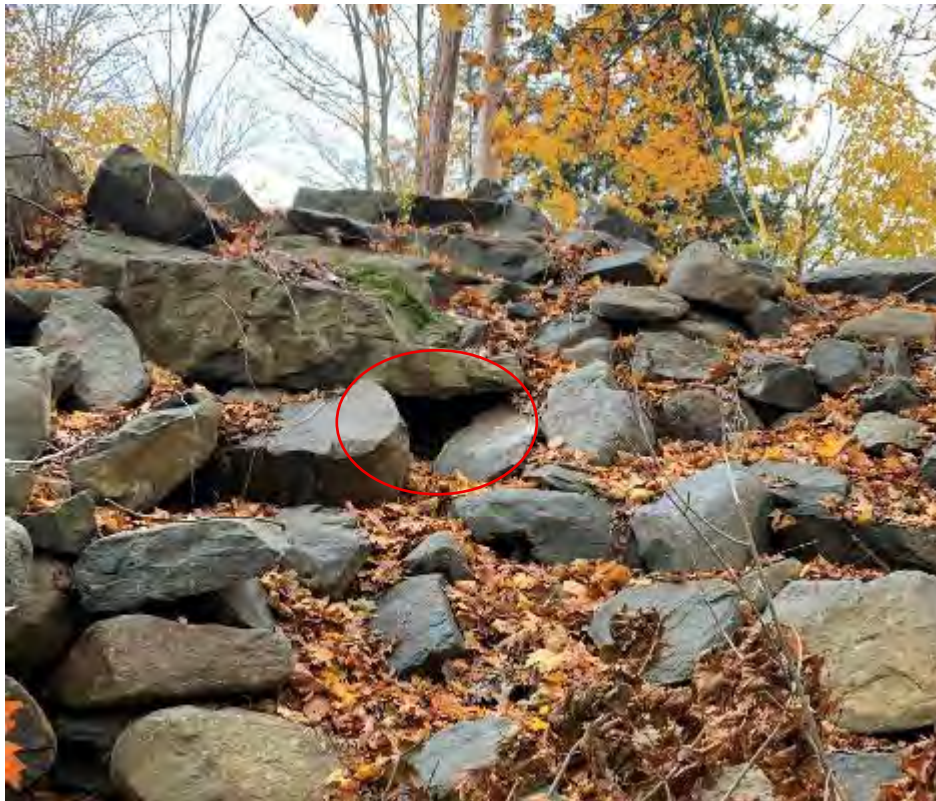
Photo 2: Voids in rock wall on downstream side of right embankment.

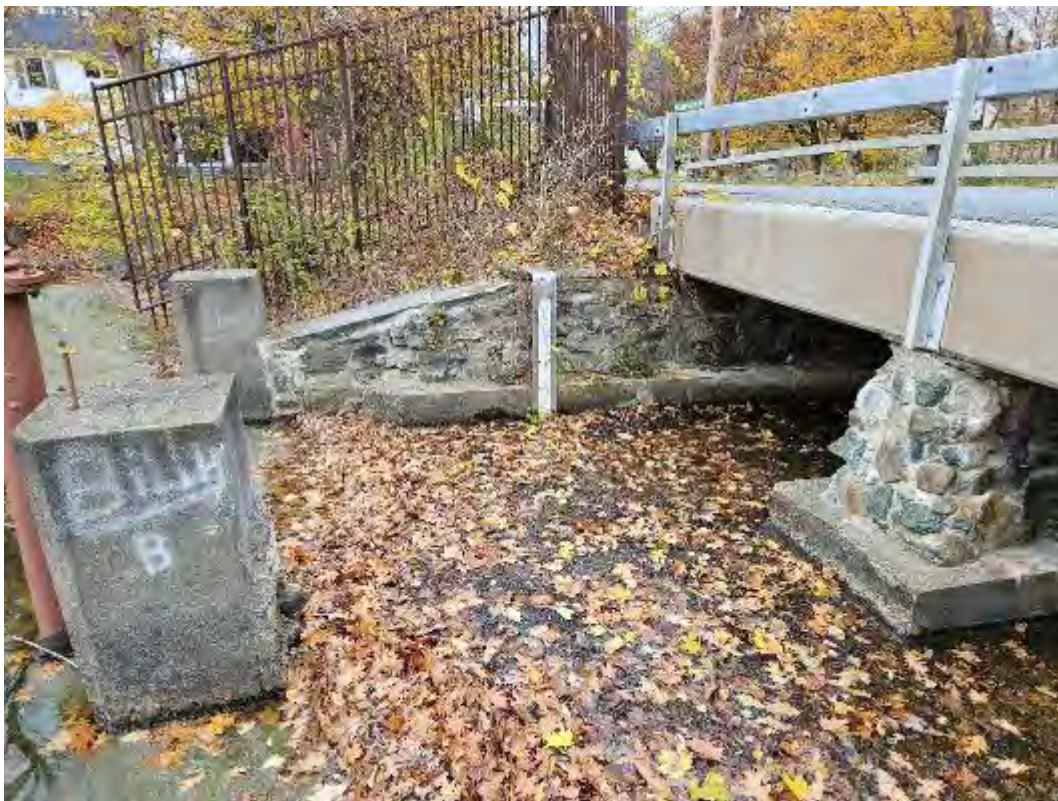
Photo 3: Spillway crest.

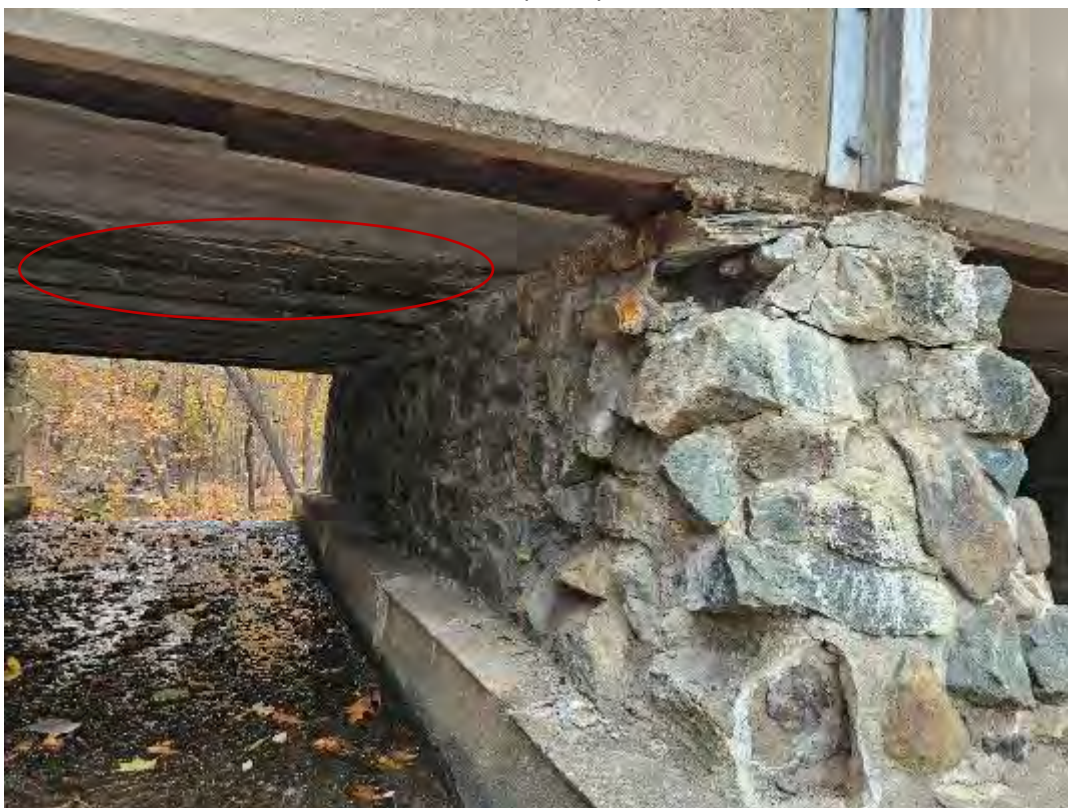
The spillway and adjacent structures were inspected from multiple vantage points and are generally in serviceable condition, though several deficiencies were noted. Concrete columns at the upstream end and the spillway crest appear intact (Photo 3), though leaf litter limited full observation. Minor erosion was identified on the center pier. The underside of the bridge deck exhibits significant concrete spalling and exposed rebar, and the bridge should be formally inspected and repaired (Photo 4).

Photo 4: Bridge and abutment at spillway crest. Note erosion and exposed rebar under bridge deck.

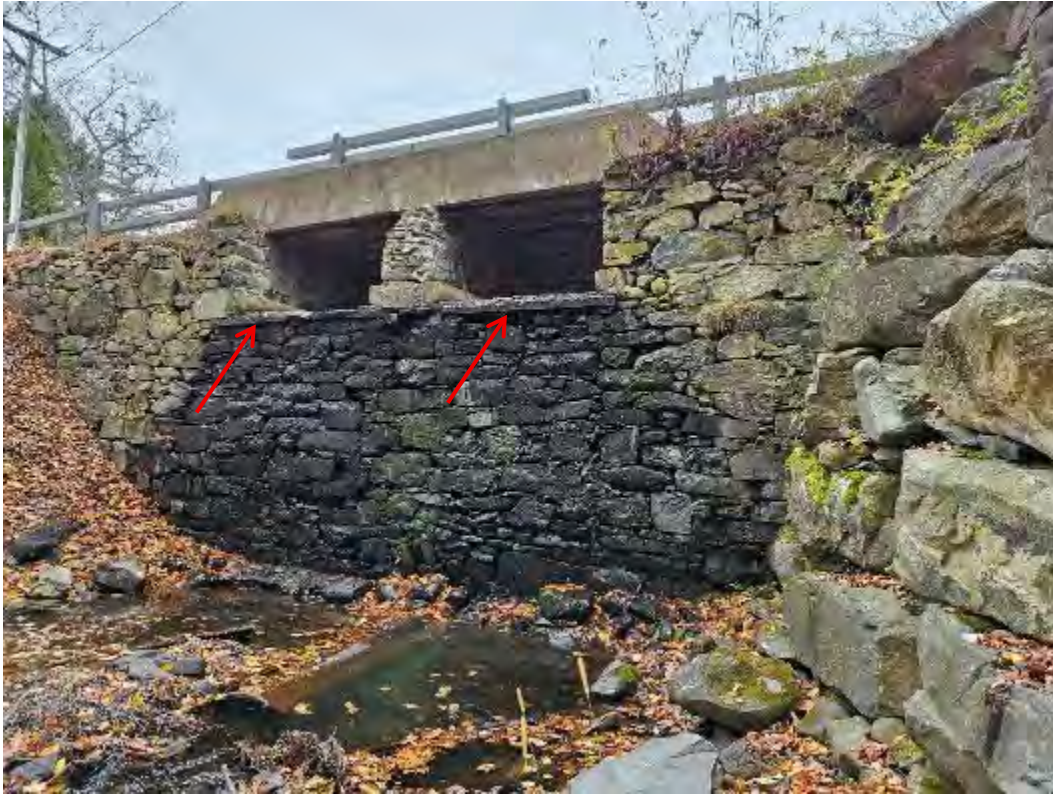
Photo 5: Downstream face of dam. Note wooden planks.

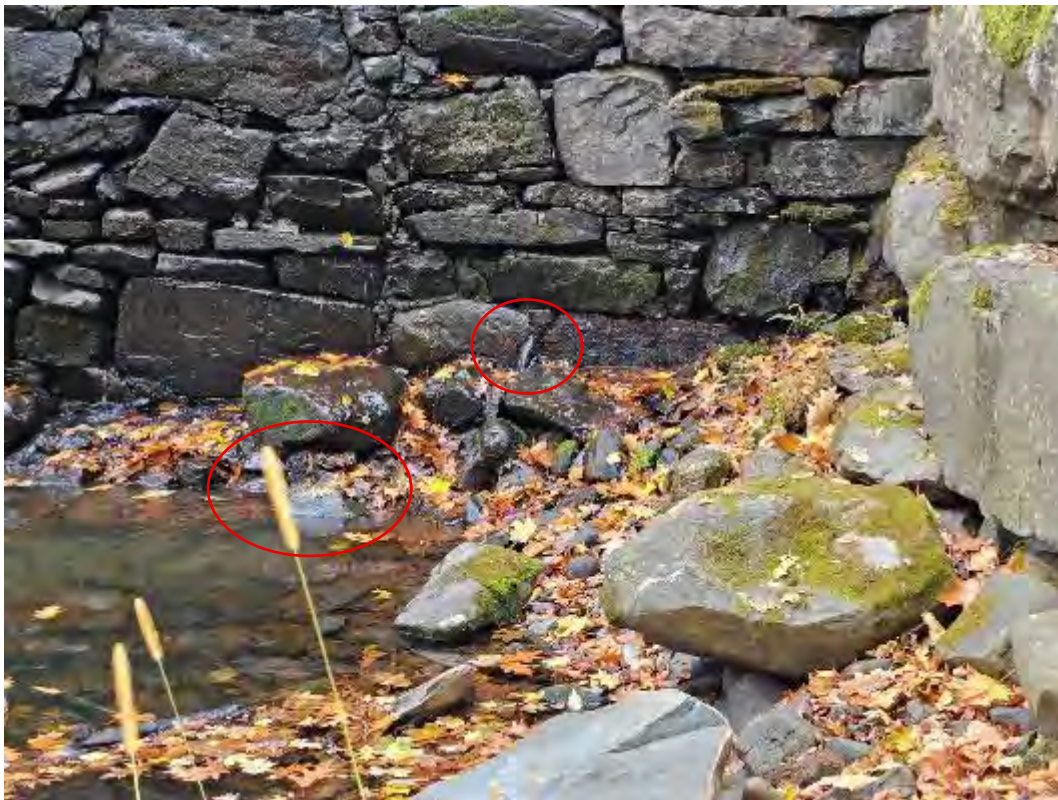
Downstream, the vertical masonry face of the dam and spillway is generally in good condition, though wood planks over the spillway crest show moderate deterioration (Photo 5). Seepage was observed at several locations—primarily near the base left of the spillway and beneath the concrete pad—but flows were clear with no sediment. These seeps should continue to be monitored for changes in flow or turbidity (Photo 6).

Photo 6: Location of seepage at base of dam.

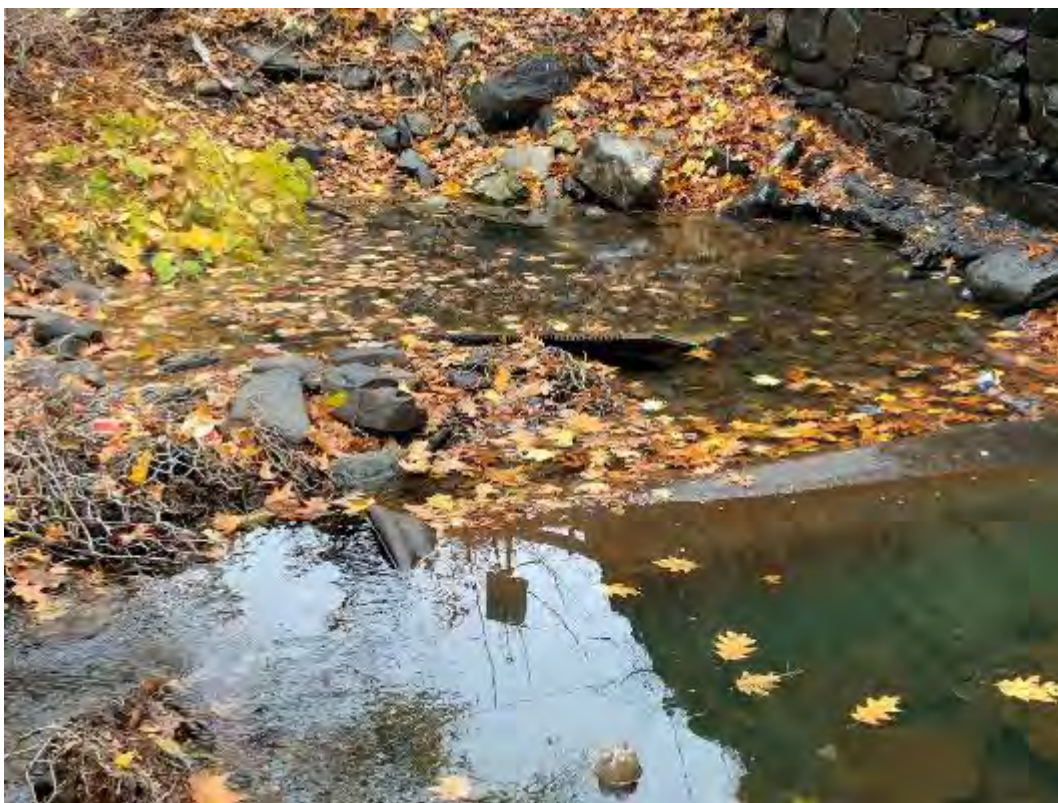
Photo 7: Low-level outlet at base of spillway.

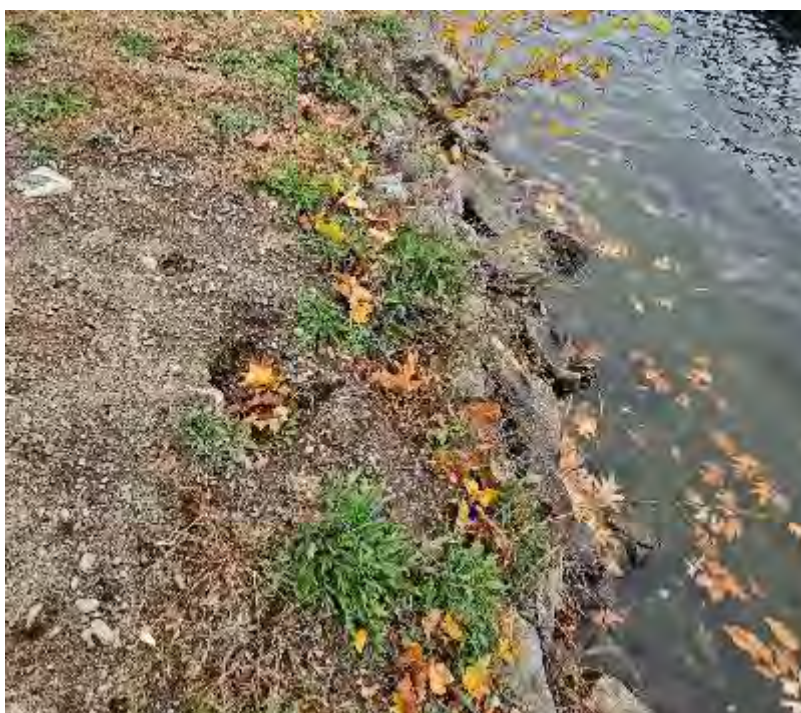
Photo 8: Animal burrow on crest of dike.

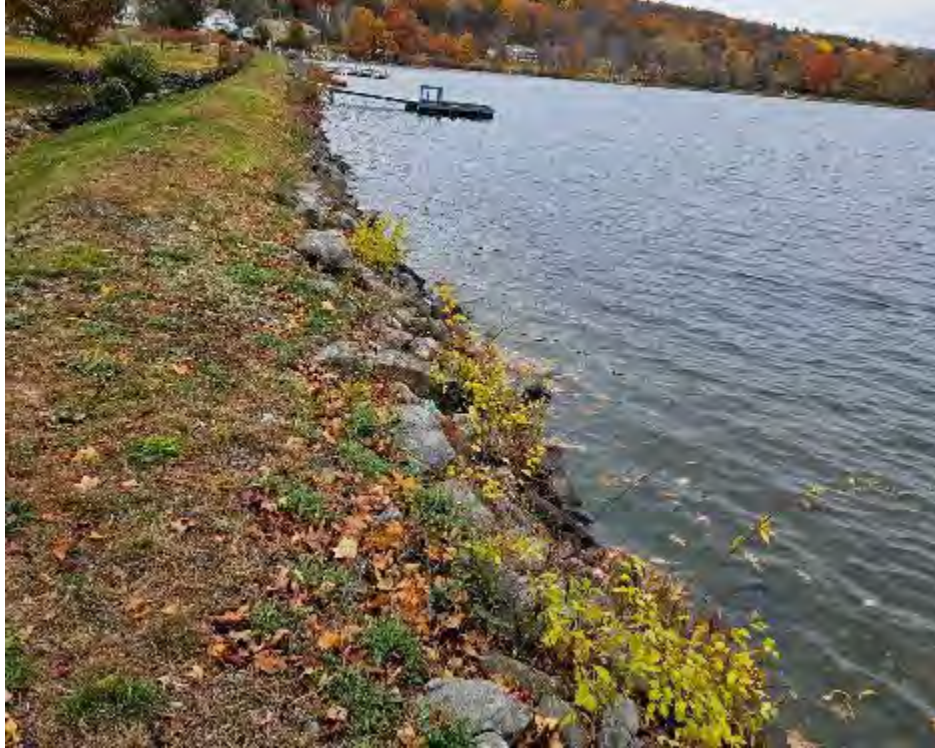
The earthen dike along the north side of the reservoir was inspected from the crest, upstream slope, and downstream slope. The crest is grass-covered with some bare areas and an uneven surface likely caused by recreational use. Rodent burrows, minor sloughing, and localized erosion were observed along the embankment (Photo 8). The upstream slope includes partial riprap near the waterline, with brushy overgrowth and bare areas where riprap or vegetation is sparse; the upper slope is grass-covered. Various recreational structures—such as stairs and docks—are present on the upstream slope (Photo 9).

Photo 9: Upstream slope of dike from west end looking east.

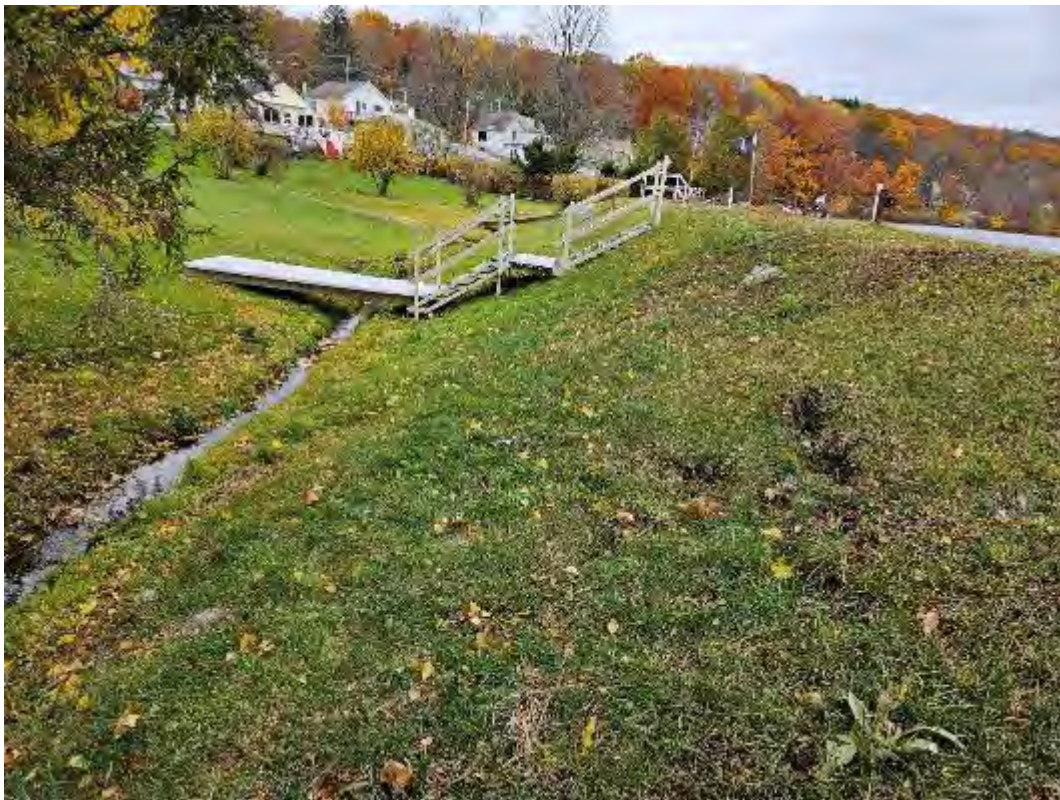
Photo 10: Stormwater ditch at toe of dike. Note recreational features on dike.

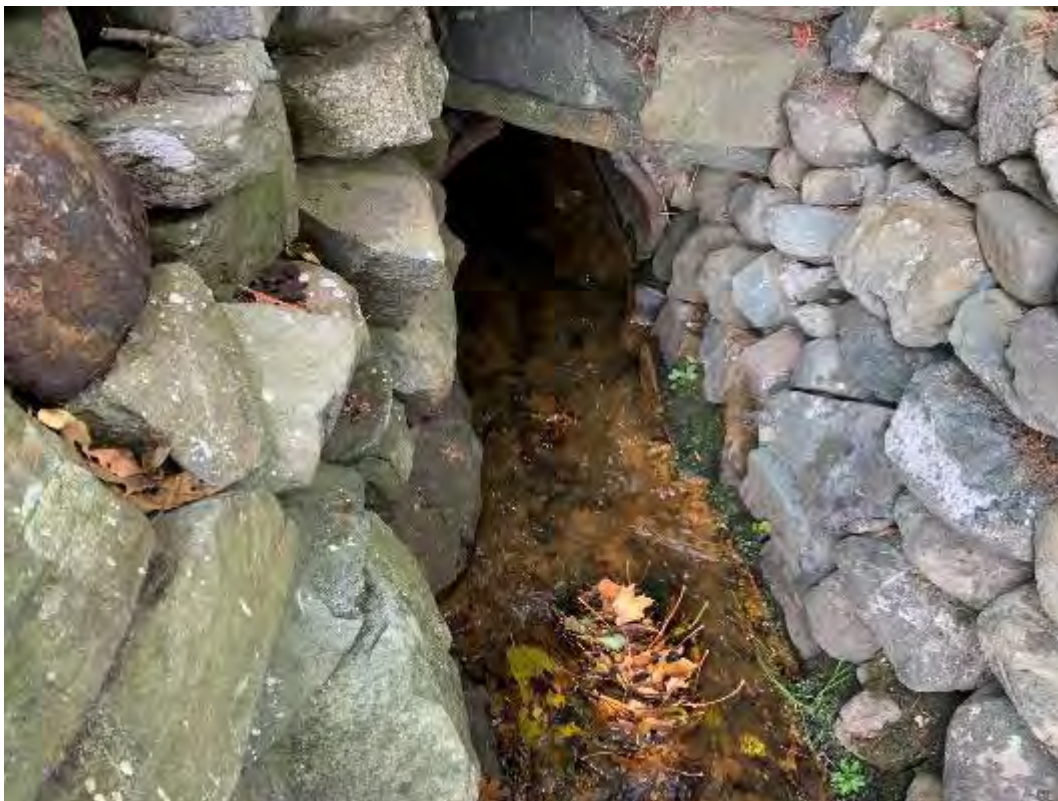
The downstream slope is generally in good condition, grass-covered with minor localized erosion. Additional recreational structures, including stairs and small bridges, cross the stormwater ditch at the toe. The ditch alternates between open grass- or rock-lined sections and culverts; while most sections are in good condition, some culverts show minor deterioration. The ditch ultimately discharges through a culvert beneath Glass Lake Road downstream of the spillway (Photos 10 and 11).

Photo 11: Deteriorating culvert section in stormwater ditch.

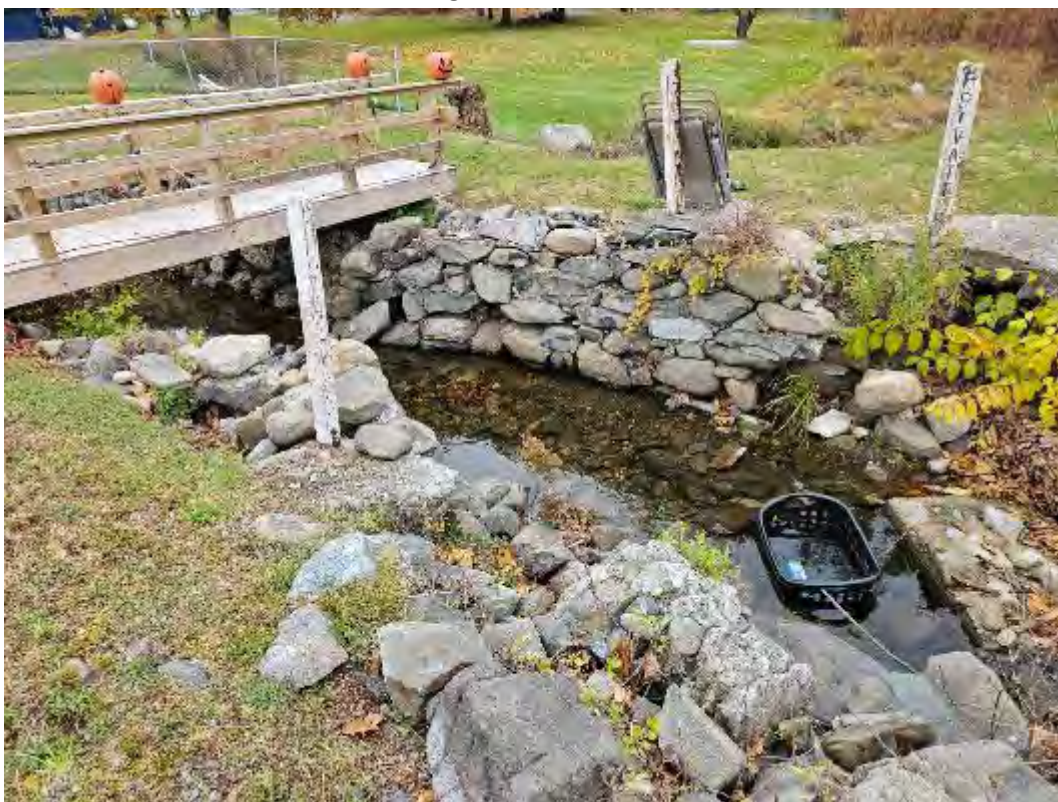
Photo 12: Tributary through dike. Note footbridge.
