# Glass Lake Aquatic Macrophyte Inventory Report

# 2022 Aquatic Macrophyte Inventory Report

Glass Lake is a 126 acre lake located in Sand Lake, Rensselaer County, New York, surrounded by residences, forests, and inflowing wetlands and springs. SOLITUDE Lake Management was hired to conduct vegetation monitoring in September 2022 to meet the obligations of Article 24 Freshwater Wetlands Permit #DEC #4-3840-00166, issued as part of the 2021 application of ProcettaCOR EC to control invasive eurasian watermilfoil in Glass Lake. These survey results can be used to track changes in the vegetation community, and also to determine future management methods within the waterbody.

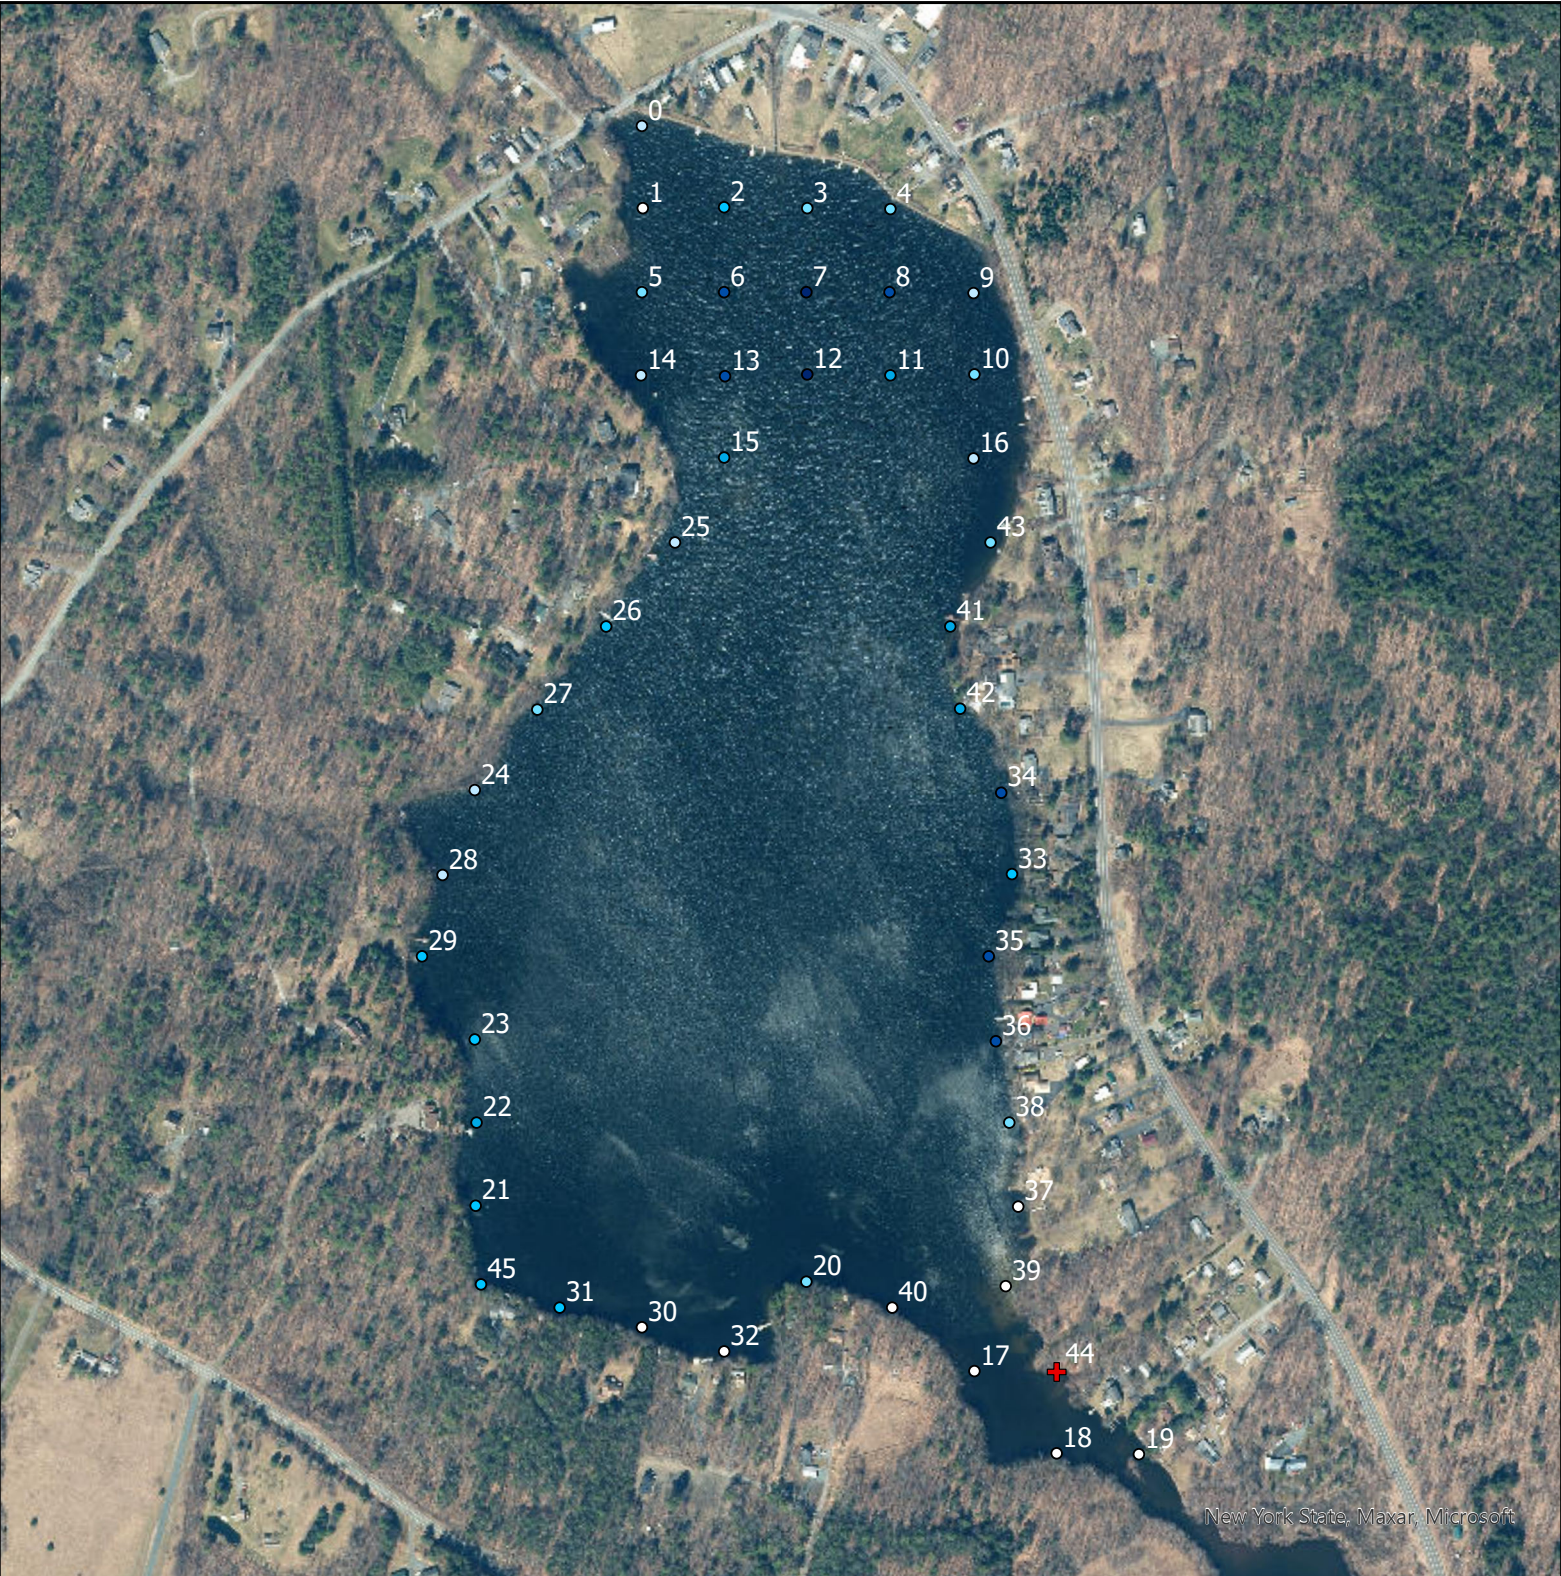
# Figure 1: Survey Points and Depths Glass Lake

During the survey, each predetermined GPS survey point was accessed by boat in a feasible locational order. At each point, a single rake toss was executed to determine the present macrophyte species. The following data was collected for each rake toss: water depth, aquatic vegetation composition, including species identification and dominant species, coverage and density information for each species, and percentage of cover of floating-leaf species. No emergent/wetland vegetation was recorded unless the data point was directly within that habitat zone. The surveyed data points are displayed in Figure 1, attached in Appendix B.

A total of 46 sites were surveyed on September 19, 2022 (Figure 1 in Appendix B), where seventeen (17) aquatic macrophytes and macroalgae were identified during the survey (Table 1, below). The weather was overcast on the day of the survey, and approximately 75 degrees Fahrenheit. Raw data and macrophyte distribution maps can be found in Appendices A and B, respectively.

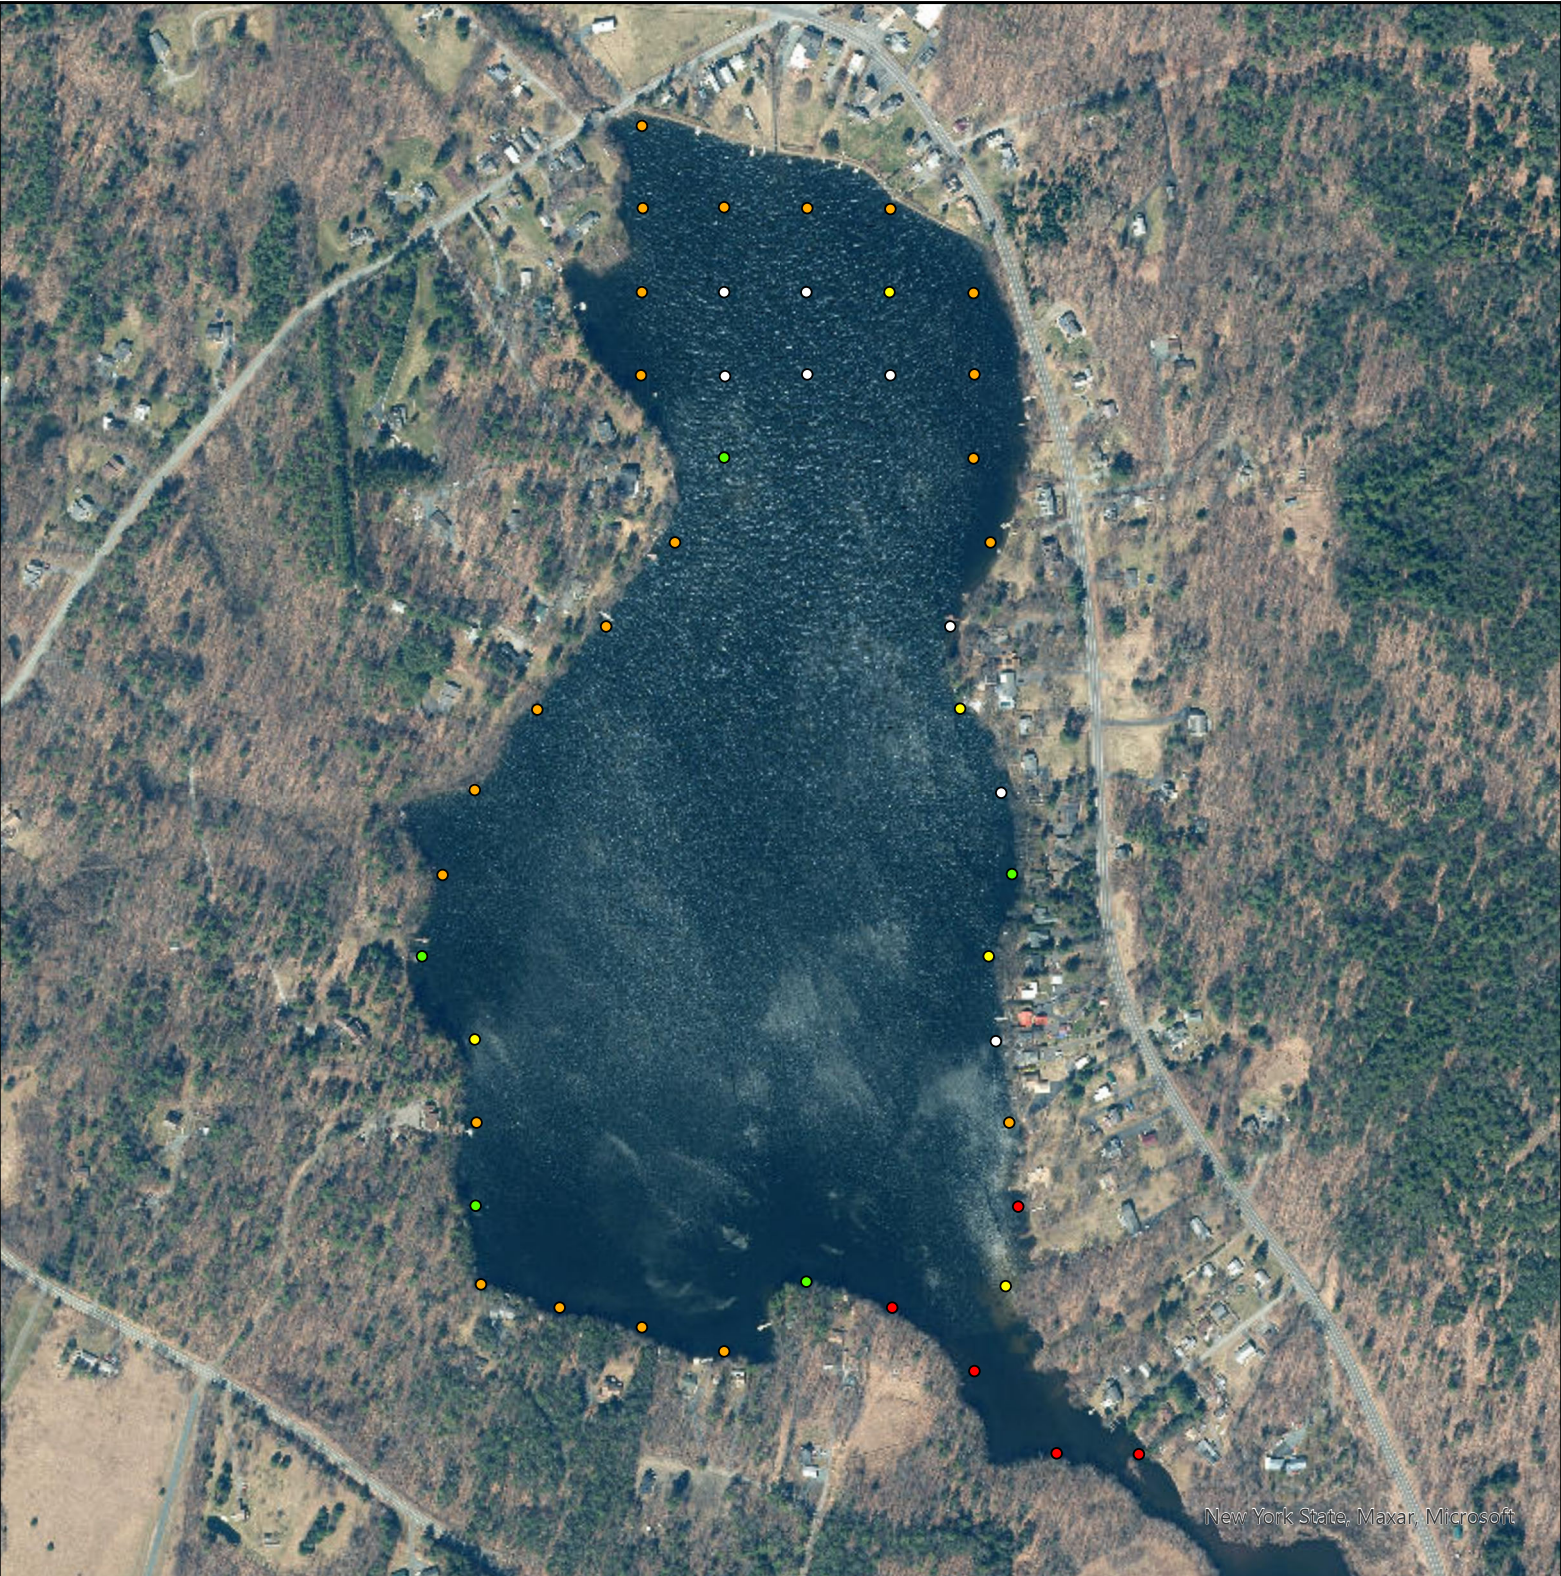
Figure 3: Percent Coverage of Submersed Aquatic Vegetation - Glass Lake

Overall cover is defined as the percentage of bottom sediments obscured by vegetation. In general, an area in which no sediments are visible was classified at 100% cover; at times however bottom sediments are not visible due to water clarity or depth, regardless of vegetative growth. At these points, the overall cover was estimated by the amount of plants collected on the throw-rake. This number was recorded for both submersed species and floating-leaf species at each survey point. Overall cover is displayed on an attached map (Figure 3).

The average overall percent (%) cover of vegetation at the survey data points was 49%. This percentage includes any submersed aquatic vegetation species. The overall cover of floating-leaf species at the data survey points was 4%, and consisted of white and yellow water-lilies. Figure 4 displays the floating-leaf species and their abundance among the survey sites.

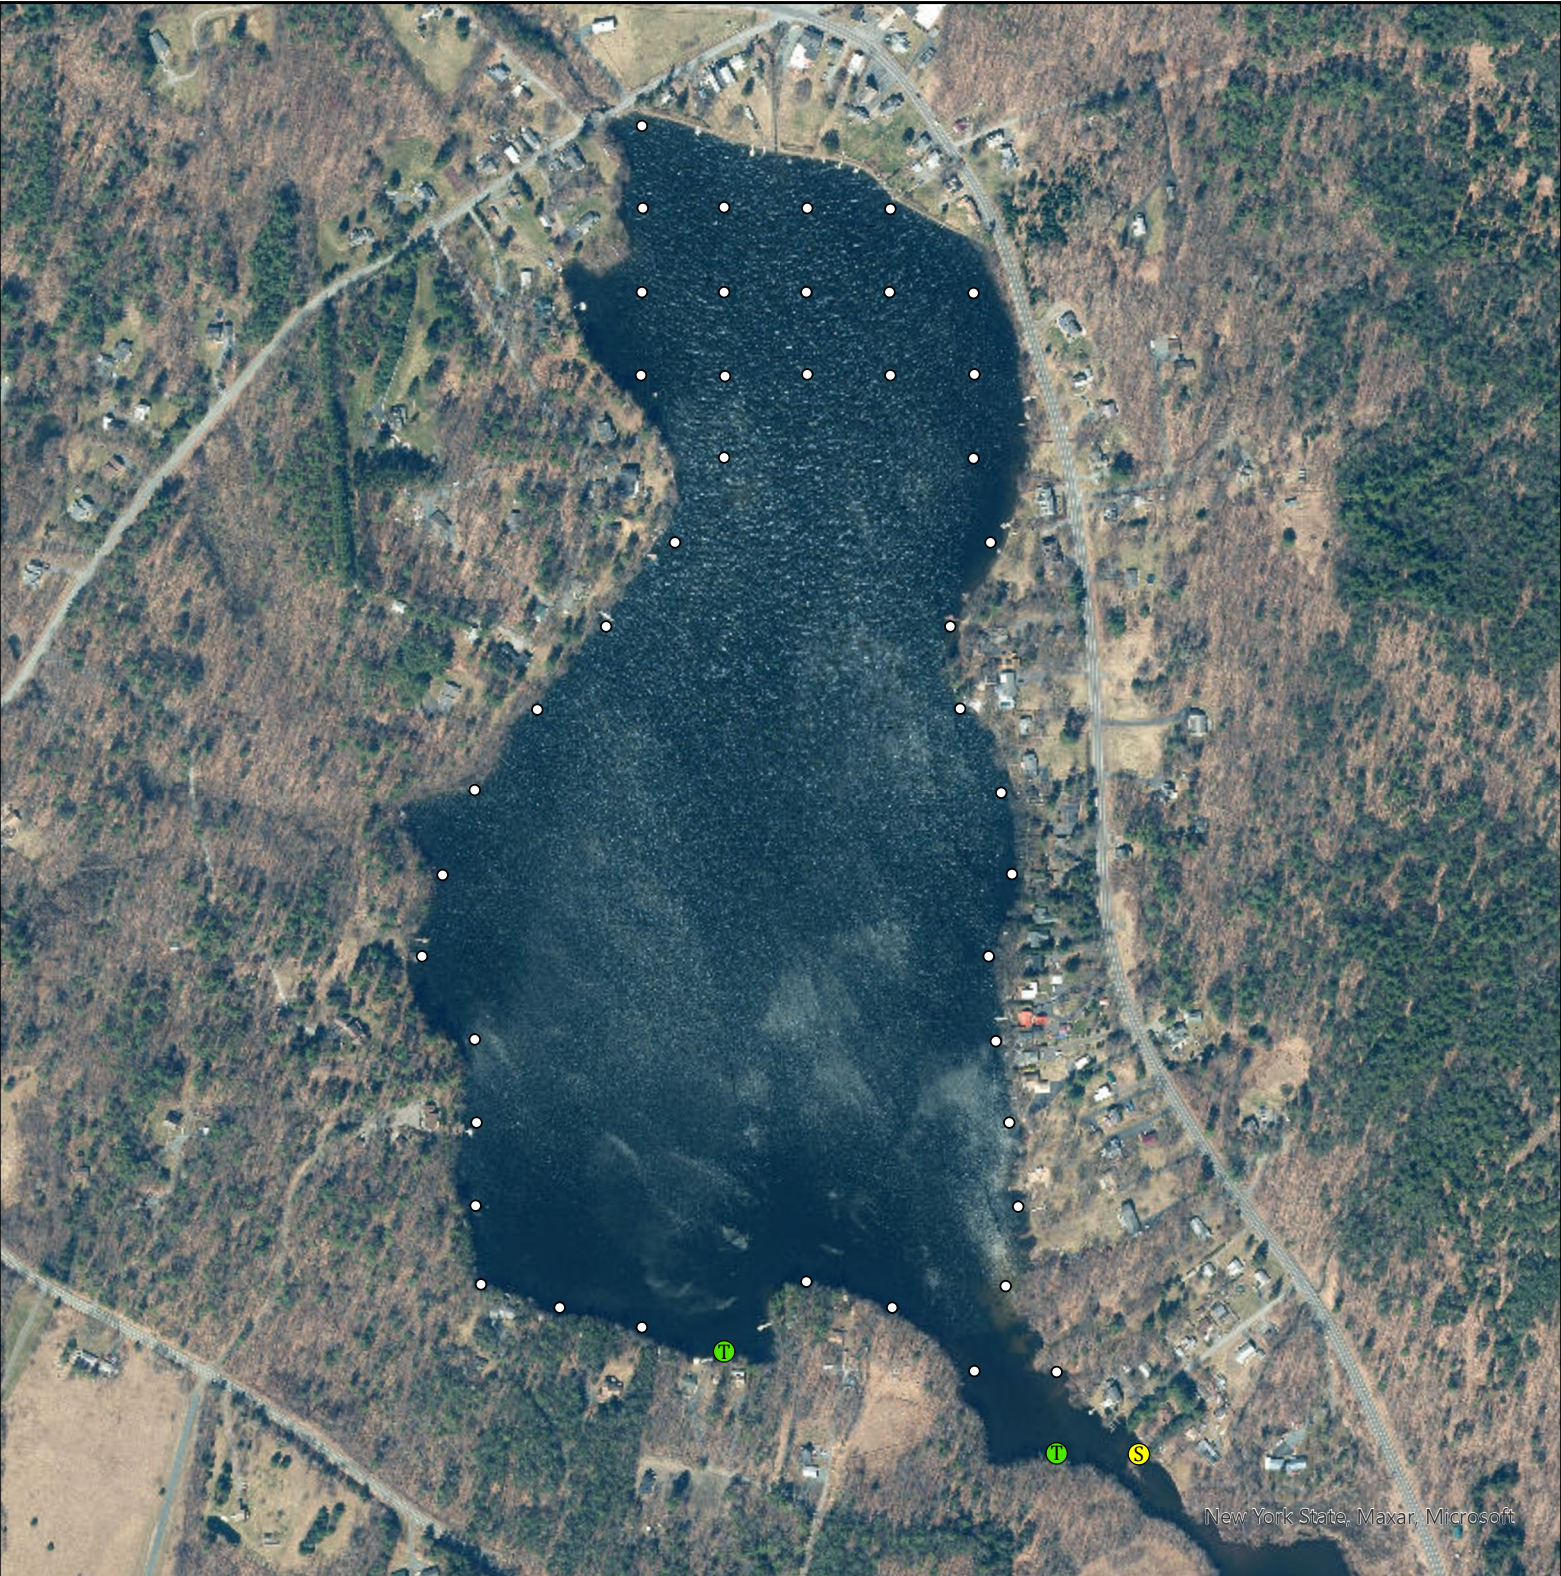
Figure 5: Relative Abundance of Eurasian Watermilfoil - Glass Lake

Overall, aquatic macrophytes were observed at all but nine survey sites (80%), at which the depth of the water was greater than ten feet. The macrophyte community was dominated by Robbins' pondweed (*Potamogeton robbinsii*), which was present at 78% of sites in varying densities. Eurasian watermilfoil (*Myriophyllum spicatum*) was present at only 7% of sites (3), and was found at trace to sparse density.

Only a few small patches of Eurasian watermilfoil were observed at the survey points (7%) and can be visualized on the map in Appendix B (Figure 5: Relative Abundance of Eurasian Watermilfoil). Each patch was observed at trace to sparse density in 2022. Attached Figure 7 shows the locations of Eurasian watermilfoil during the 2019 pre-treatment survey.

Therefore, no treatment to control Eurasian watermilfoil is recommended in 2023 in Glass Lake. It is recommended to continue with yearly monitoring surveys to observe any changes to the invasive and native diversity within the Lake.
