# ENGINEERING ASSESSMENT

Glass Lake Dam

NYSDEC ID# 226-1344

FINAL REPORT

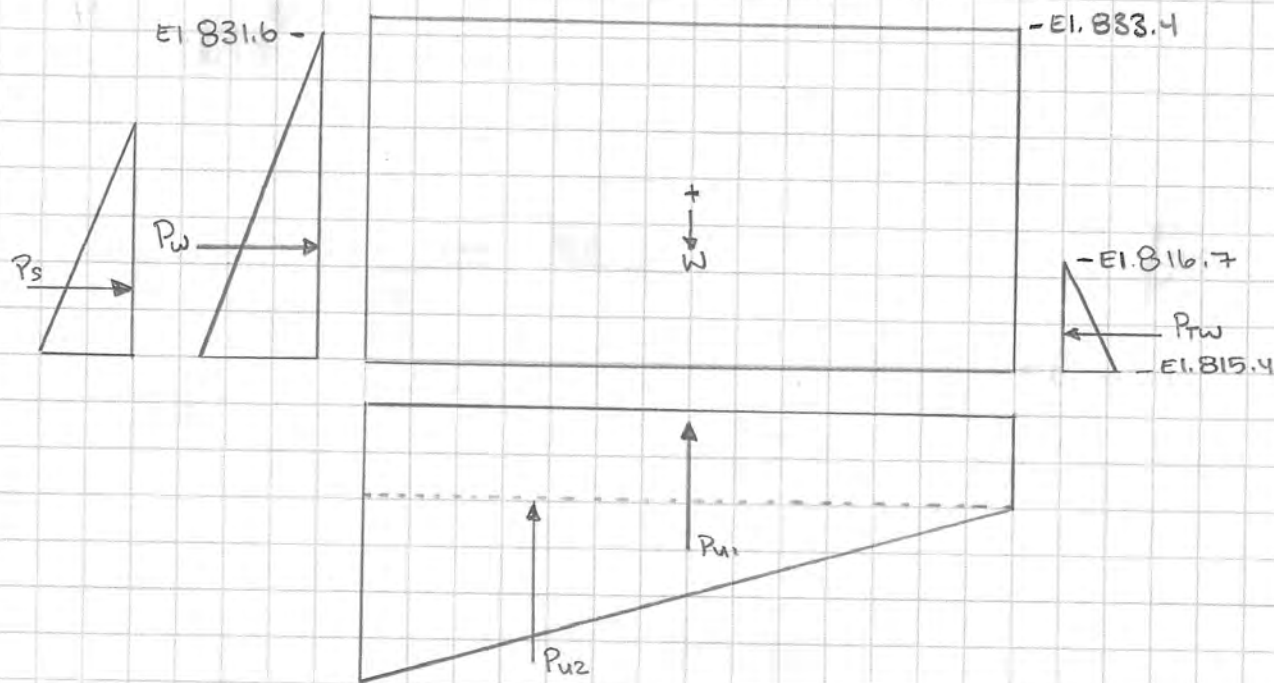
CASE III - SDF @ El. 831.6, TW @ El. 816.7 (per GSE 2026)

Note, DS "TW" pressure neglected

+ Water Pressure,  $P_w = (831.6 - 815.4)^2 (1/2) (62.4) = 8.18 \text{ kip}$   
arm = 5.4 ft  
 $M_w = 44.17 \text{ kip ft}$

+ Uplift,  $P_{u1} = (816.7 - 815.4) (34) (62.4) = 2.76 \text{ kip}$   
arm = 17 ft  
 $M_{u1} = 46.89 \text{ kip ft}$

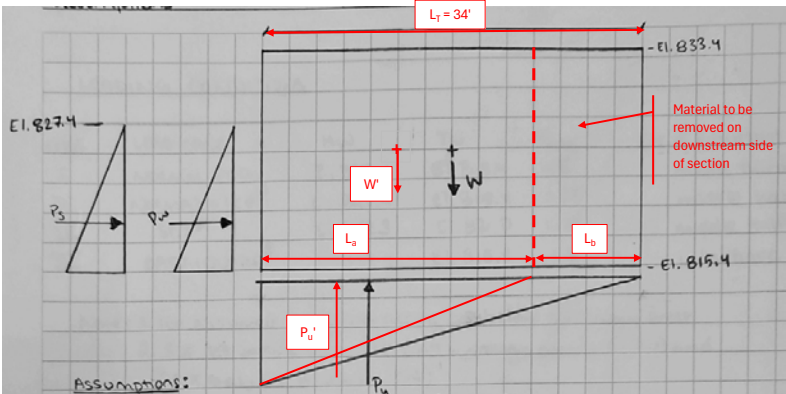
As discussed in the previous section, in March 2026, a portion of the stone façade on the downstream face of the non-overflow section failed, exposing the granular fill material within the dam. As of the preparation of this report, repairs are currently in design with construction to occur in the near future. Gomez and Sullivan was requested by the dam owner to evaluate the stability of the dam and estimate how much material could be lost from the downstream section.

For this analysis, an excel spreadsheet was utilized to calculate how much material could be lost from the downstream side of the non-overflow section before the recommended minimum factor of safety against sliding was met. This analysis only considered normal and normal and ice loading as it was assumed repairs would be made to the structure prior to a significant flood event and/or a seismic event. Fill material was assumed to fall away from the structure and leave a vertical face. This is generally unrealistic as the soil would likely fall to some angle leaving a sloped face. However, the vertical face is more conservative (it assumes more material is removed from the structure than if the soil slopes back) and is generally easier to analyze. Additionally, any stabilizing effects from the concrete pad below the earthen fill was ignored.

$L_1 = L_2 = L_T$   
 $L_1$  = length of section to remain  
 $L_2$  = length of section removed  
 $W'$  and  $P_u'$  = Weight and uplift forces revised for geometry of dam section to remain.

Based on this analysis, it is recommended that no more 24 feet of material be removed from the dam face either due to the continued removal of material on the downstream face or during construction.

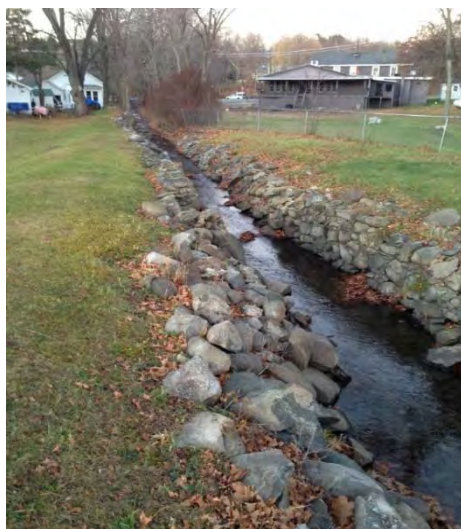
**FIGURE 5-1: DITCH DRAINING SUB-BASIN NO. 1 AND DISCHARGING INTO GLASS LAKE THROUGH GLASS LAKE DIKE**

Glass Lake sub-basin 1 drains directly behind the Glass Lake Dike through a small channel which releases water into Glass Lake through the Dike (Figure 5-1). Some of the water from sub-basin 1 is also collected in a small ditch, which runs at the Dike toe, and conveys water into a two feet diameter pipe underneath Glass Lake Road to the Wynant Kill.

Channel draining Sub-basin 1

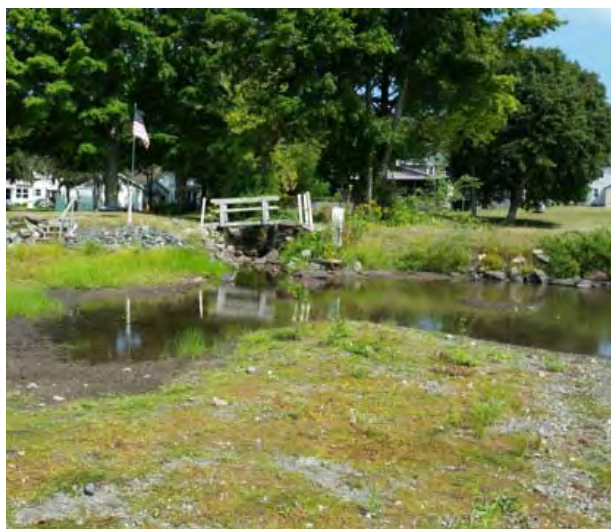
Channel outlet into Glass Lake through the Glass Lake Dike

During significant flood events, water accumulates behind the dike prior to eventually releasing into the Wynants Kill. This phenomenon is due to the relatively flat slope of the ditch as well as the limited capacity of the pipe underneath Glass Lake Road. During Hurricane Irene, in August 2011, the water built up only inches behind the dike's crest to an elevation significantly superior to the water elevation observed in Glass Lake. The hydraulic model developed for this project simulates this situation. Results are presented into the subsequent sections.

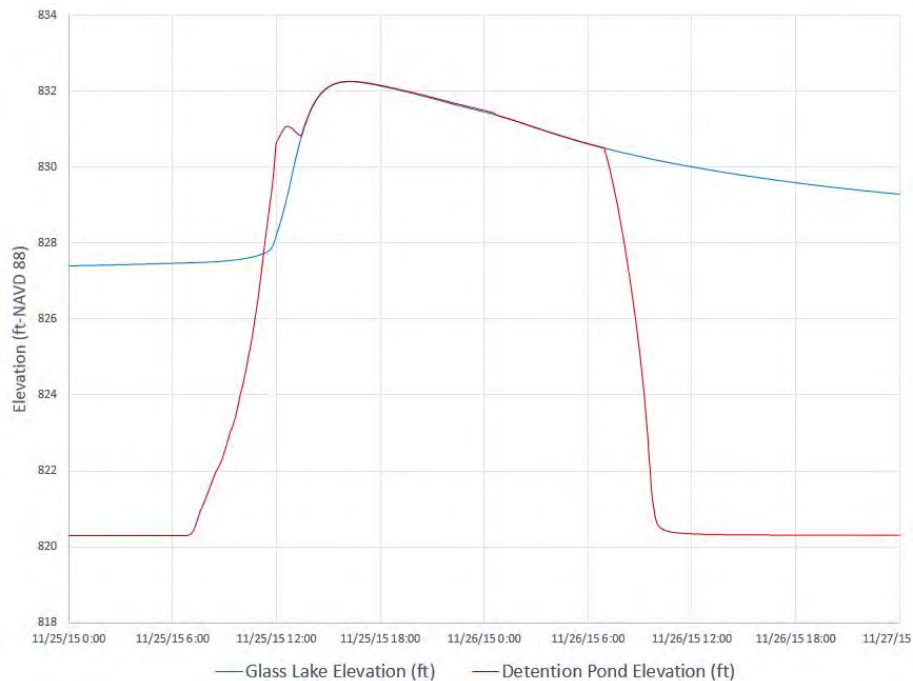
**FIGURE 6-1: GLASS LAKE AND DETENTION POND'S WATER SURFACE ELEVATIONS DURING THE SDF**

The SDF, as defined by the NYSDEC, is the largest flood that a given spillway is designed to pass safely. For a Class 'B' Intermediate Hazard Dam, this corresponds to a flood event equal to 150% of the 100 year flood. This flood scenario is simulated using the developed HEC-HMS model. The fluctuation of the water elevations in Glass Lake and within the Low-lying area ("detention pond") is presented on Figure 6.1.

During the SDF storm event, the hydraulic analysis demonstrates that the water level in the detention pond rises quicker than in Glass Lake and that the Dike eventually overtops when the water elevation reaches El. 830.5 ft. At this point, water flows from the detention pond into Glass Lake overtopping the Dike crest.

Subsequently, the water level in Glass Lake continues to rise due to discharge from its other upstream watersheds. The water level rises above the Dike crest elevation (830.5 ft.) and flows back into the detention pond. The water level in Glass Lake and the detention pond continue to rise until they peak at 832.3 ft. at which point the water surface elevation begins to fall. As the water level falls, the detention pond and Glass Lake are continually connected until the water surface elevation hits 830.5 ft. and the detention pond is cut off from Glass Lake by the Dike. Once the detention pond is isolated from Glass Lake, the water surface elevation in the detention pond drops much faster.

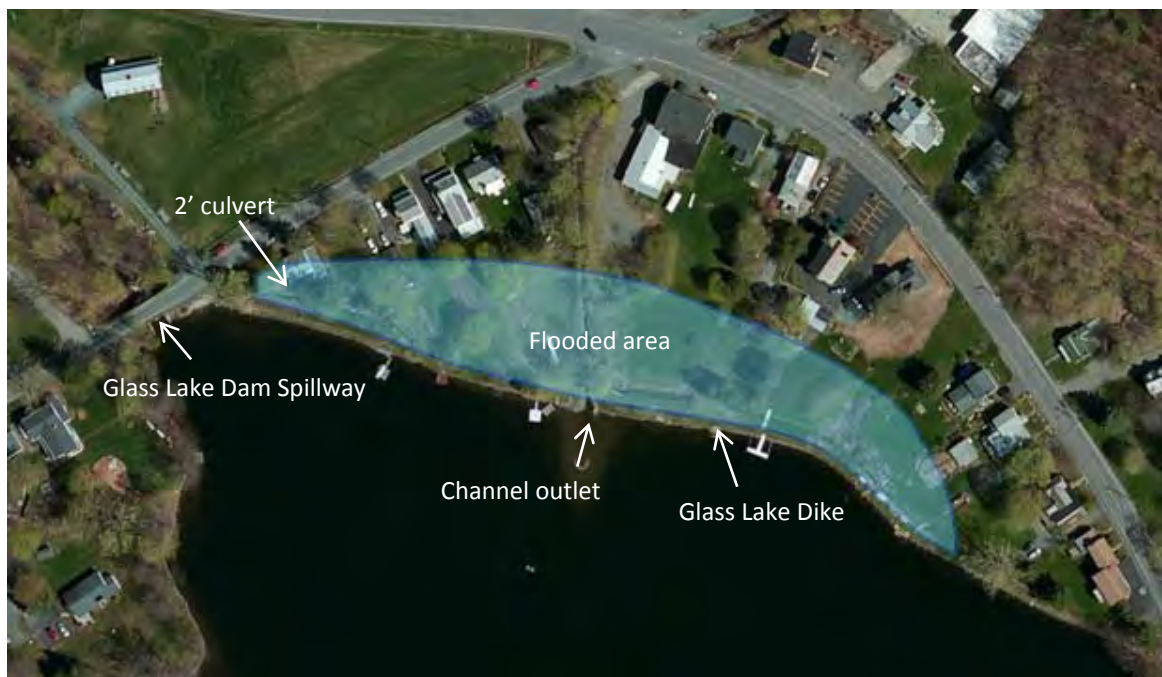
**FIGURE 6-2: LOW-LYING AREA DOWNSTREAM OF GLASS LAKE DAM WITH WATER EL. AT 832.3**

The masonry dam and Glass Lake Road overtop as well, by about 0.3 ft. for a limited period of time.

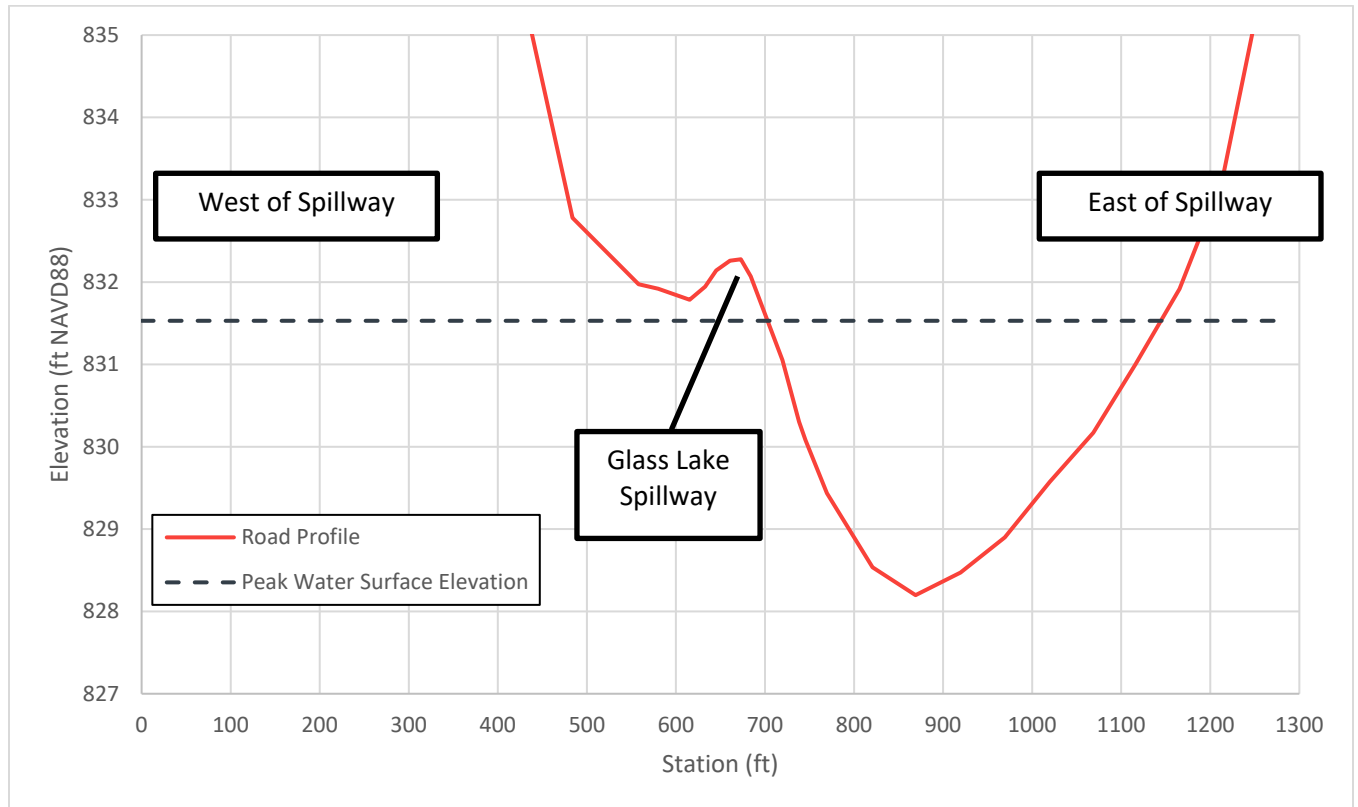
*Figure 8: Glass Lake Road Profile at Peak Water Surface Elevation*

Based on the results, the spillway section and western abutment of Glass Lake Dam does not overtop during the SDF. However, the embankment section of the Dam dividing the Detention Pond and Glass Lake overtops by 1.1 ft, which rapidly fills the Detention Pond. With the Detention Pond full, Glass Lake Road east of the Dam overtops by up to 3.3 ft at the lowest road crest elevation. Overall overtopping across Glass Lake Road occurs for 14.5 hours.

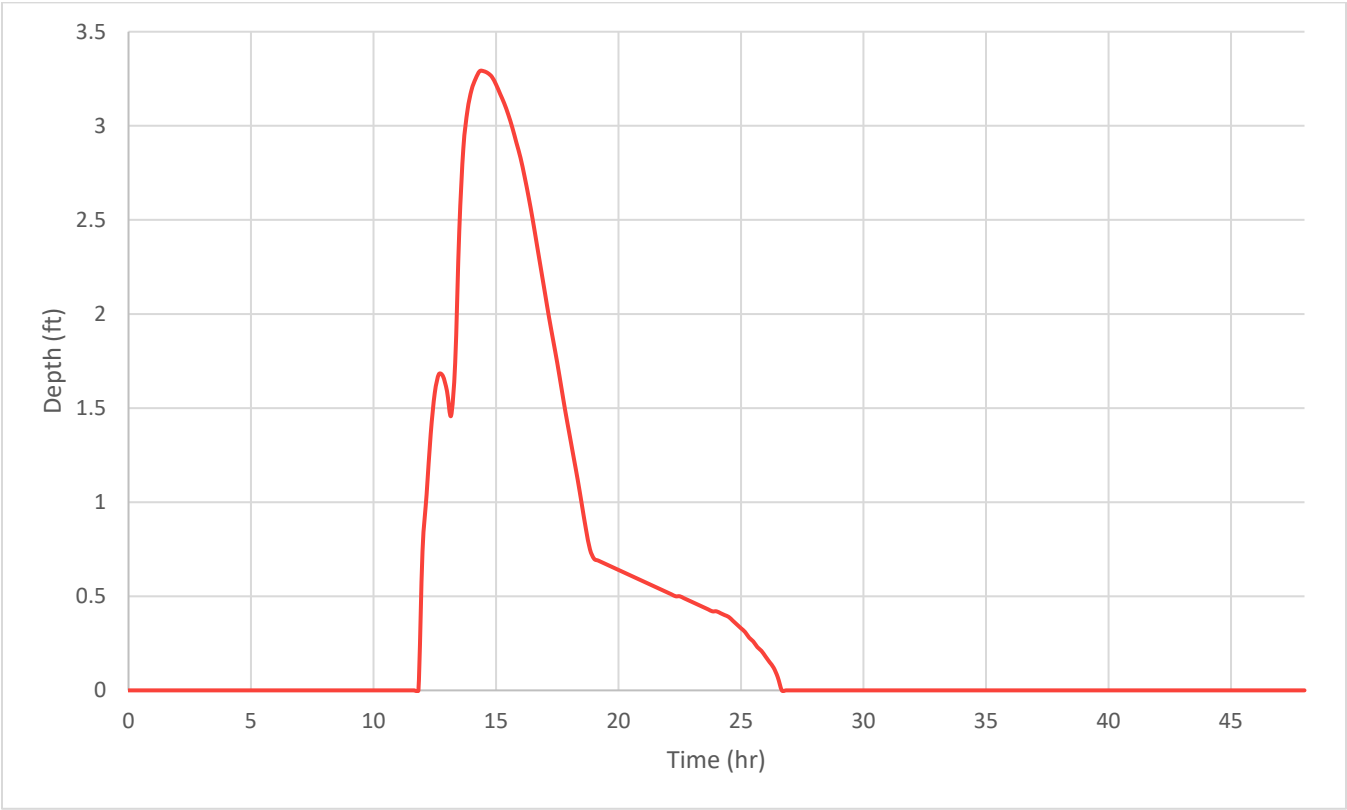
*Figure 9: Depth of Flow Over Glass Lake Road East at Point of Lowest Elevation*

The flow depth over time for the lowest spot on Glass Lake Road is plotted in Figure 9. The peak flow velocity across Glass Lake Road is approximately 1.9 ft/s.

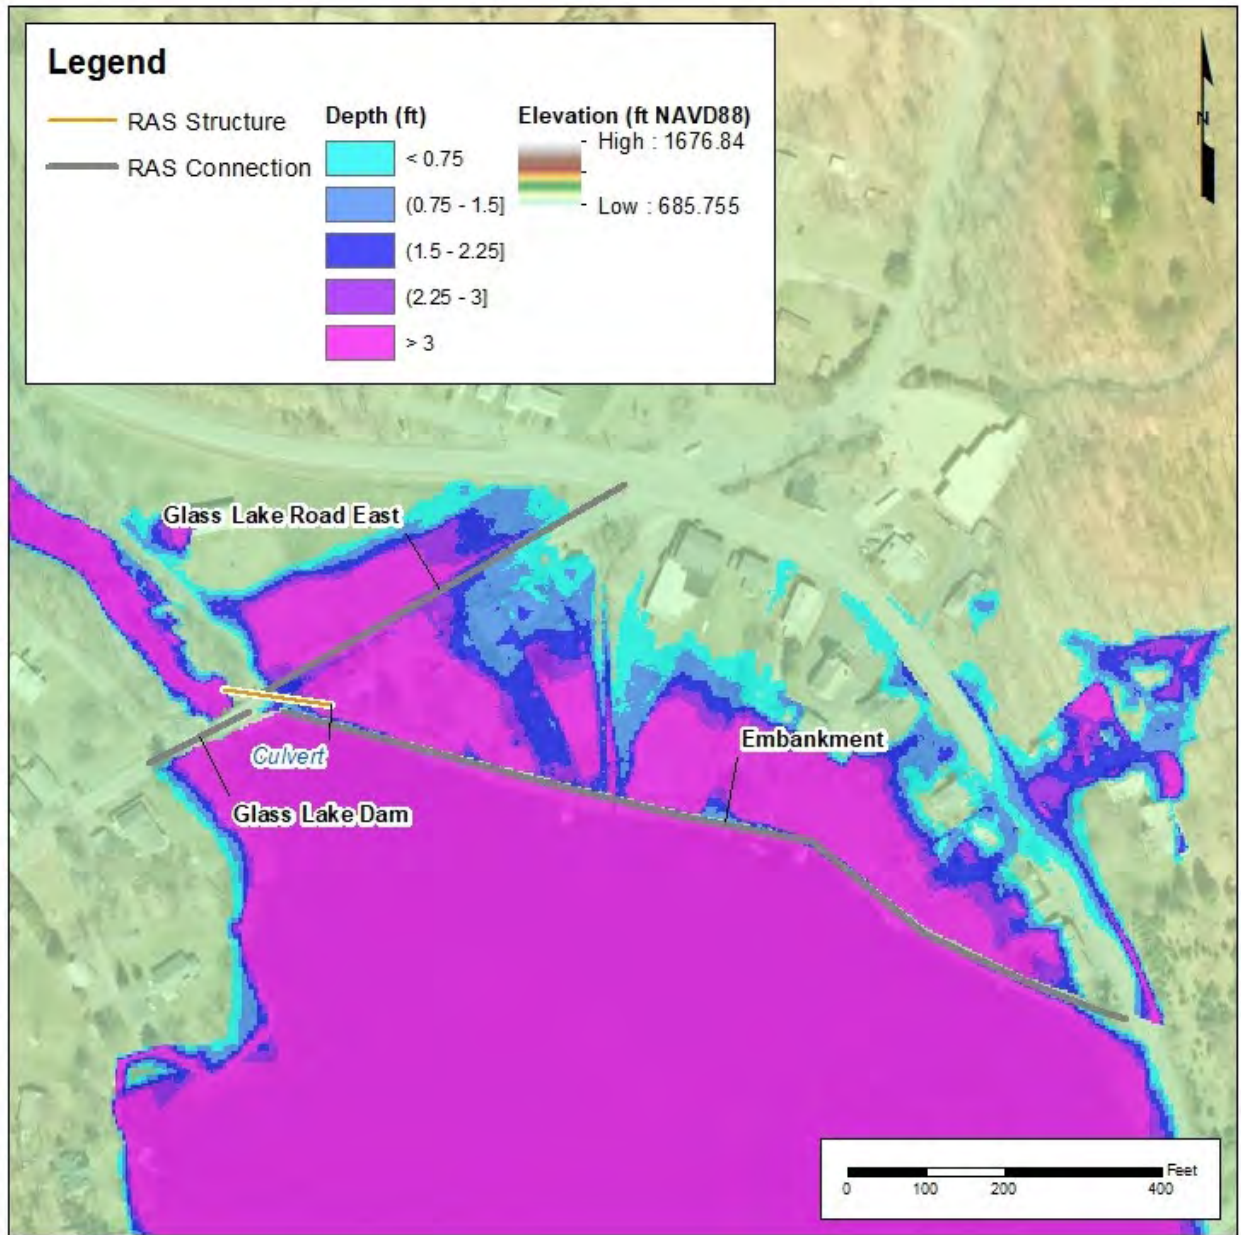
Figure 10: Maximum Depth and Flood Inundation Extents of the SDF at Glass Lake Road

Downstream of Glass Lake Road, overtopping flow quickly reenters the channel downstream of the spillway. The maximum depths and flood extent are shown in Figure 10.
